TECHNICAL REPORT M-245

June 1978

Foam Material Applications in Theater of Operations Construction

DAMAGED BUILDING REPAIR WITH POLYURETHANE FOAM

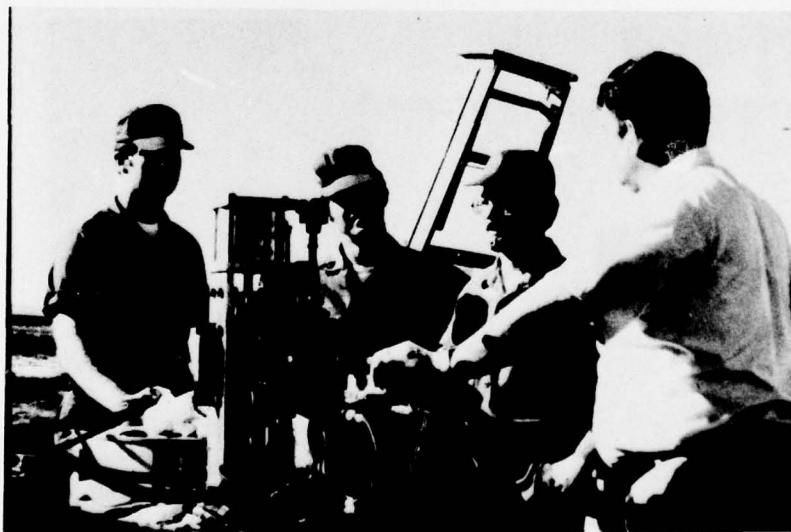
Figure 4 shows a short training session conducted to familiarize soldiers from an Army National Guard unit with the foam spray equipment and its operation. Although the trainees had never seen either foam spray equipment or application, they were able to perform satisfactorily after less than 1/2 hour of explanation and demonstration, and a brief hands-on performance period.

**Figure 4.** National Guardsmen participating in a brief training exercise.
